# Mobile Intel® Pentium® 4 Processor-M

Specification Update

*November 2003*

Document Number: 250721-020

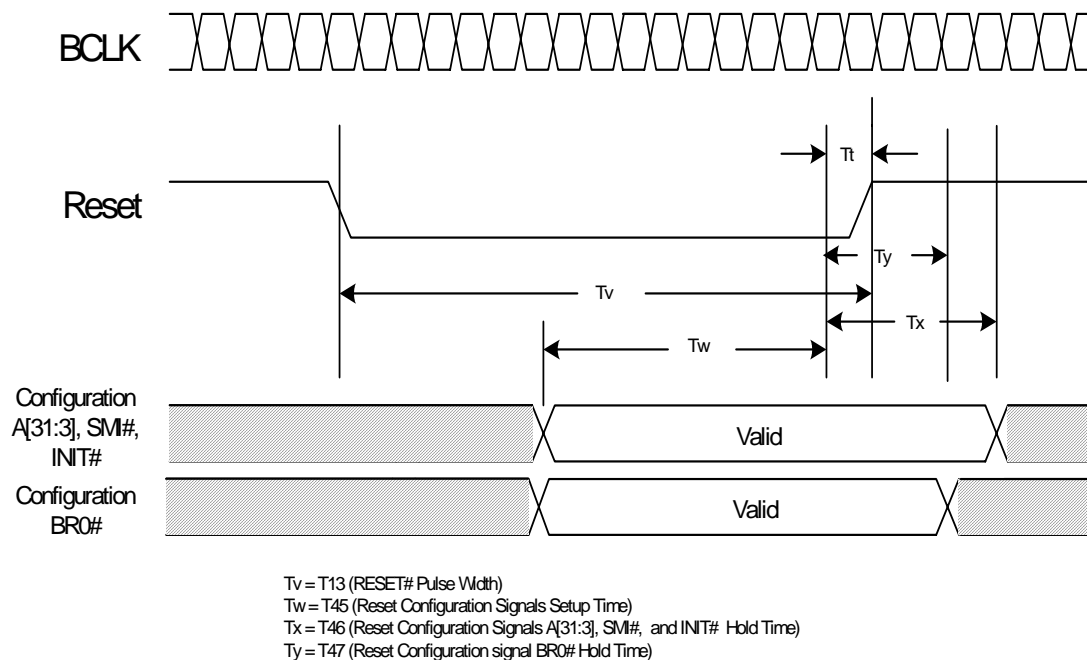
**Figure 13. System Bus Reset and Configuration Timings**

The BR0# maximum hold time has changed to 2 BCLKs. This change will be shown in the “System Bus AC Specifications (Reset Conditions)” table and “System Bus Reset and Configuration Timings” figure of the *Mobile Intel® Pentium® 4 Processor - M Datasheet*. This change will be incorporated in the next revision of the datasheet.

The following figure will be modified to reflect this change:
